Open Space Assessment 2024

**Policy and Strategy Team
October 2024**

Lichfield
District Council

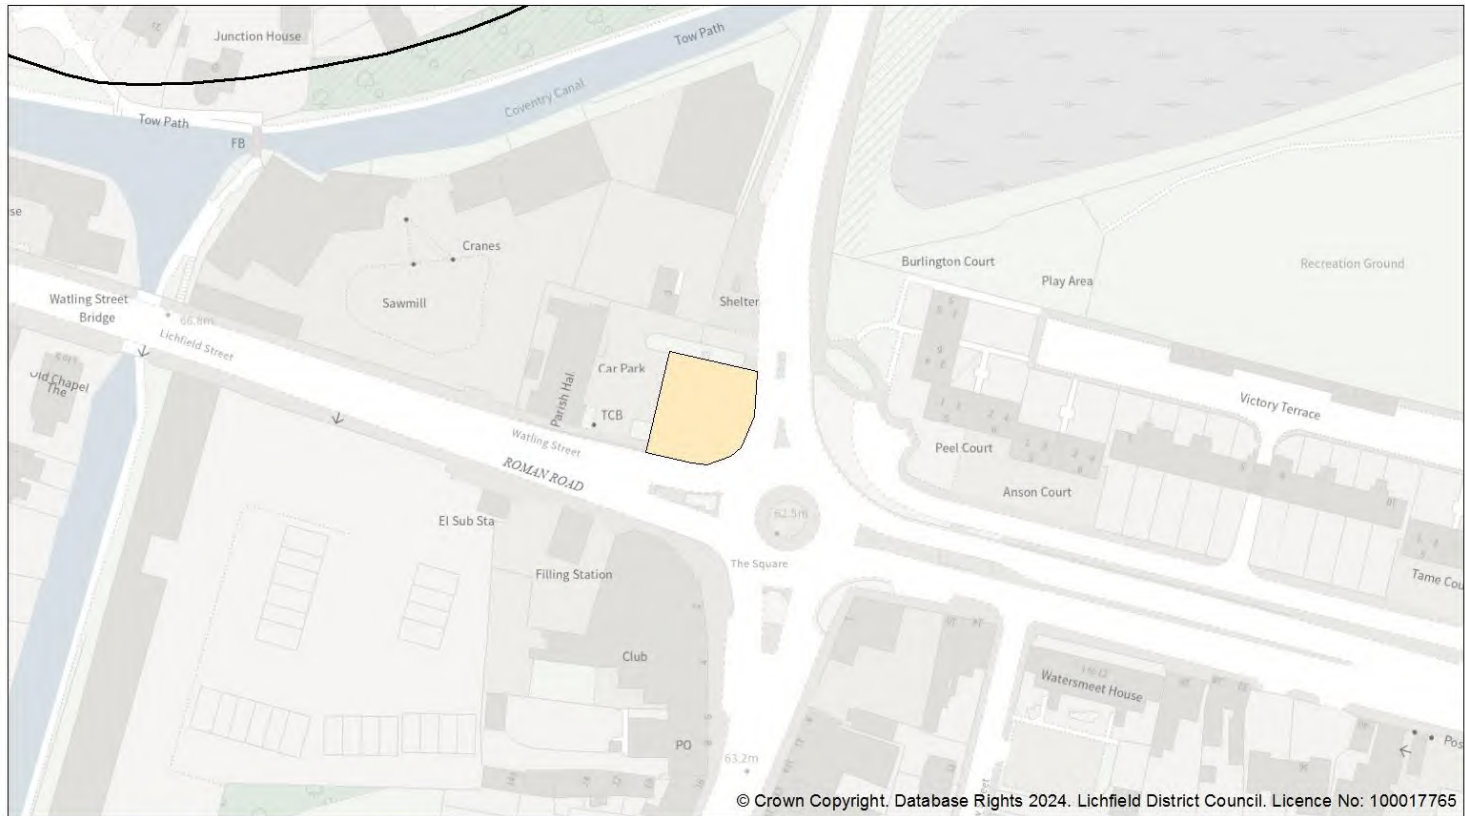
Figure 8: Fazeley Civic Space

- Cathedral Close, Lichfield
 - Garrick Square, Lichfield
- 8.5 Within the rest of the district there is only one further identified civic space which is the square fronting Fazeley Town Hall as illustrated on Figure 8.

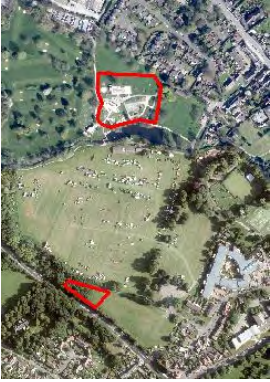
<p>Play Location</p> <p>Beacon Park, Lichfield</p> <p>Large play area with a variety of play equipment, including a basket ball park. A skate park is located on the outskirts of the park.</p>

<p>Degree to which play area is overlooked, perception of safety</p> <ul style="list-style-type: none"> Visible from footpaths Visible from properties fronting onto site, Visible by traffic – moderate residential volume and speed Visible from nearby café <p>100% overlooked -0% not overlooked</p>	<p>Degree to which site is 'inclusive'</p> <ul style="list-style-type: none"> Open during daylight Level even surfaces for pushchairs & wheelchairs Seating opportunities both formal and informal New wheelchair Swing <p>100% inclusive – 0% not inclusive</p>	<p>Proximity to other services & facilities</p> <p>Opportunities to travel to play on route to other events</p> <ul style="list-style-type: none"> Shops, community buildings, school Café & kiosk Scout hut Pavilion <p>100% multi facilities – 0% no facilities</p>	<p>Does it have highest catchment coverage</p> <p>Within 480m /10 min walk time</p> <p>100% full residential coverage – 0% no coverage</p>	<p>Accessibility barriers</p> <p>Physical</p> <ul style="list-style-type: none"> Railway lines, busy roads, canals, poor footpath links etc. <p>Social</p> <ul style="list-style-type: none"> Local youth disputes, negative attitudes of residents to children <p>100% no barriers – 0% barriers</p>	<p>Play value – Children's criteria (must have at least 5 out of 7)</p> <ul style="list-style-type: none"> Opportunities to run/walk Hard surface to cycle, basketball, roller stake, skateboard Ability to play ball games Opportunities to sit/hang out Risky play – climbing, jumping, swinging Natural play – hills, tress Well maintained – bins, litter <p>100% 5 out of 7 – 0% 0 out of 7</p>	<p>Equipment quality</p> <p>Broken equipment or in need of repair</p> <p>100% excellent condition – 0% poor condition</p>	<p>Overall comments</p> <p>An excellent park which offers a wide variety of play opportunities. There is something for all ages and both equipped and natural play is available.</p> <p>Equipment and the wider area is well maintained. Addition of a wheelchair swing to make the play area more inclusive and accessible</p>

<p>Score</p>								
60%	100%	100%	80%	100% Physical, 100% Social	100%	100%		
<p>Comments</p>								
<p>Due to its location in a large park the play areas are not visible from properties or roads. The play areas are visible from footpaths within the park and by users from other parts of the park. The park café overlooks the majority of the play area. It also has a ranger service throughout the year during daylight hours.</p>	<p>Site provides excellent range of equipment, seating areas (both formal and informal) and pathways, all to a high standard and suitable for all users.</p>	<p>The park is within walking distance of the city centre and adjacent to a supermarket. There are also a number of facilities within the park.</p> <p>Christchurch school is within 250m of the skatepark and around 500m from the play area..</p>	<p>A large part of the catchment covers the rest of Beacon Park and parts of the city centre with few residential properties within the 480m buffer. However the park is a destination which many people outside of the 480m catchment will travel to use. As such this catchment isn't appropriate for this sight.</p>	<p>Physical: None</p> <p>Social: None</p>	<p>Opportunities to run/walk, Hard surface, Ability to play ball games, Opportunities to sit/hang out, Risky play, Natural play, Well maintained.</p> <p>Park provides a range of natural and equipped play for all ages. The play area is set within the wider Beacon Park which offers other recreational activities and opportunities.</p>	<p>The play equipment and skate park in Beacon Park are in excellent condition.</p>

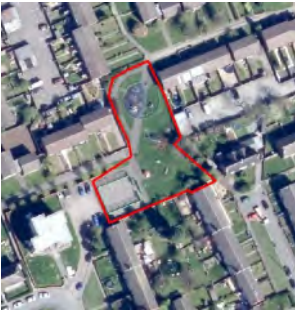
<p>Play Location</p> <p>Oakenfield/ James Greenway, Lichfield</p> <p>This site hosts a MUGA, small children's play area and some equipment for older children.</p>

<p>Degree to which play area is overlooked, perception of safety</p> <ul style="list-style-type: none"> Visible from properties fronting onto site, Visible by traffic – moderate residential volume and speed Visible from footpaths <p>100% overlooked - 0% not overlooked</p>	<p>Degree to which site is 'inclusive'</p> <ul style="list-style-type: none"> Open during daylight Level even surfaces for pushchairs & wheelchairs Seating opportunities both formal and informal <p>100% inclusive – 0% not inclusive</p>	<p>Proximity to other services & facilities</p> <p>Opportunities to travel to play on route to other events</p> <ul style="list-style-type: none"> Shops, community buildings, school <p>100% multi facilities – 0% no facilities</p>	<p>Does it have highest catchment coverage</p> <p>Within 480m /10 min walk time</p> <p>100% full residential coverage – 0% no coverage</p>	<p>Accessibility barriers</p> <p>Physical</p> <ul style="list-style-type: none"> Railway lines, busy roads, canals, poor footpath links etc. <p>Social</p> <ul style="list-style-type: none"> Local youth disputes, negative attitudes of residents to children <p>100% no barriers – 0% barriers</p>	<p>Play value – Children's criteria (must have at least 5 out of 7)</p> <ul style="list-style-type: none"> Opportunities to run/walk Hard surface to cycle, basketball, roller stake, skateboard Ability to play ball games Opportunities to sit/hang out Risky play – climbing, jumping, swinging Natural play – hills, tress Well maintained – bins, litter <p>100% 5 out of 7 – 0% 0 out of 7</p>	<p>Equipment quality</p> <p>Broken equipment or in need of repair</p> <p>100% excellent condition – 0% poor condition</p>	<p>Overall comments</p> <p>There is a lot of play equipment in this small site, something to suit all ages.</p> <p>Equipment looks well used but is in need of refurbishment.</p> <p>Maintenance needs improving, graffiti and litter throughout the site.</p> <p>Consider whether there is potential to add play value through natural play.</p>

Score													
100%		100%		100%		100%		100% Physical, 80% Social		100%		60%	
Comments													
Overlooked on all sides. Not visible from traffic. Footpath through site		Even surfaces, Formal and informal seating		Close to shops, Willows school.		Site has full residential catchment.		Physical: No physical barriers Social: Site is messy & unkempt, graffiti & litter present.		Opportunities to run/walk, Hard surfaces, Ability to play ball games, Opportunities to site/hang out, Risky play.		Majority of play equipment looks tired and needs refurbishing, all in working order still.	
Suggested Improvements													
None		None		None		None		Improve maintenance of site to reduce litter & graffiti		Consider whether there is potential to add play value through natural play. Maintenance of the site needs improving.		Majority of equipment needs refurbishing.	
Max score													
100%		100%		100%		100%		100% / 100%		100%		100%

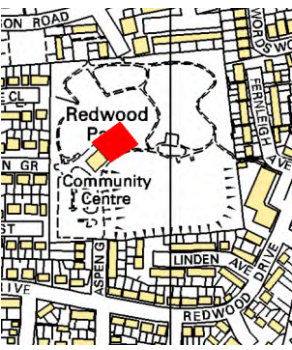
Play Location	Degree to which play area is overlooked, perception of safety	Degree to which site is 'inclusive'	Proximity to other services & facilities	Does it have highest catchment coverage	Accessibility barriers	Play value – Children's criteria (must have at least 5 out of 7)	Equipment quality	Overall comments
<p>Redwood Park, Burntwood</p> <p>Play equipment for a variety of ages, and a MUGA.</p>

<ul style="list-style-type: none"> Visible from properties fronting onto site, Visible by traffic – moderate residential volume and speed Visible from footpaths <p>100% overlooked -0% not overlooked</p>	<ul style="list-style-type: none"> Open during daylight Level even surfaces for pushchairs & wheelchairs Seating opportunities both formal and informal <p>100% inclusive – 0% not inclusive</p>	<p>Opportunities to travel to play on route to other events</p> <ul style="list-style-type: none"> Shops, community buildings, school <p>100% multi facilities – 0% no facilities</p>	<p>Within 480m /10 min walk time</p> <p>100% full residential coverage – 0% no coverage</p>	<p>Physical</p> <ul style="list-style-type: none"> Railway lines, busy roads, canals, poor footpath links etc. <p>Social</p> <ul style="list-style-type: none"> Local youth disputes, negative attitudes of residents to children <p>100% no barriers – 0% barriers</p>	<ul style="list-style-type: none"> Opportunities to run/walk Hard surface to cycle, basketball, roller stake, skateboard Ability to play ball games Opportunities to sit/hang out Risky play – climbing, jumping, swinging Natural play – hills, tress Well maintained – bins, litter <p>100% 5 out of 7 – 0% 0 out of 7</p>	<p>Broken equipment or in need of repair</p> <p>100% excellent condition – 0% poor condition</p>	<p>Good site, providing a range of equipment, for a range of ages.</p> <p>Overall setting could be enhanced with some framework landscaping to increase visual interest.</p>

Score								
70%	70%	100%	100%	100% Physical, 100% Social	100%	90%		
Comments								
<p>Despite being surrounded by houses there is no direct overlooking from residential properties. Building onsite well used by a variety community groups providing a presence in the park. Park locked at night. Footpath through site well used by dog walkers.</p>	<p>Surfaces within the site level and in good condition. Seating both formal and informal. Entrance surfaces around car park are in poor condition.</p>	<p>Site is in close proximity to local schools, community building and shops.</p>	<p>Site has high residential population within its catchment.</p>	<p>Physical: None</p> <p>Social: None</p>	<p>Opportunities to run/walk, Hard surface, Ability to play ball games, Opportunities to sit/hang out, Risky play, Natural play, Well maintained.</p>	<p>Site provides a good range of equipment. Some pieces of equipment would benefit from repainting.</p>

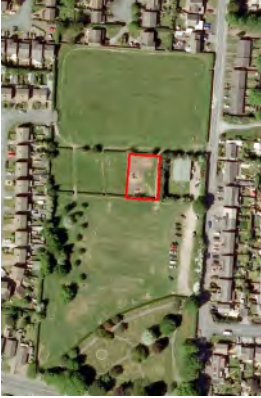
Play Location	Degree to which play area is overlooked, perception of safety	Degree to which site is 'inclusive'	Proximity to other services & facilities	Does it have highest catchment coverage	Accessibility barriers	Play value – Children's criteria (must have at least 5 out of 7)	Equipment quality	Overall comments
Burntwood Park, Burntwood Young children's play area.

<ul style="list-style-type: none"> Visible from properties fronting onto site, Visible by traffic – moderate residential volume and speed Visible from footpaths 100% overlooked -0% not overlooked	<ul style="list-style-type: none"> Open during daylight Level even surfaces for pushchairs & wheelchairs Seating opportunities both formal and informal 100% inclusive – 0% not inclusive	Opportunities to travel to play on route to other events <ul style="list-style-type: none"> Shops, community buildings, school 100% multi facilities – 0% no facilities	Within 480m /10 min walk time 100% full residential coverage – 0% no coverage	Physical <ul style="list-style-type: none"> Railway lines, busy roads, canals, poor footpath links etc. Social <ul style="list-style-type: none"> Local youth disputes, negative attitudes of residents to children 100% no barriers – 0% barriers	<ul style="list-style-type: none"> Opportunities to run/walk Hard surface to cycle, basketball, roller stake, skateboard Ability to play ball games Opportunities to sit/hang out Risky play – climbing, jumping, swinging Natural play – hills, tress Well maintained – bins, litter 100% 5 out of 7 – 0% 0 out of 7	Broken equipment or in need of repair 100% excellent condition – 0% poor condition	Fairly well located within dense residential area, however location of play area is possibly not the best. It is particularly hidden from view, this could affect perception of safety. Lack of footpath through site, and on adjacent road may be an issue.

Score								
40%	75%	50%	100%	80% Physical, 100% Social	100%	100%		
Comments								
Site is located in the middle of a large green space, adjacent to a small building. Though visibility is limited due to high hedges and its location. It gives an enclosed appearance somewhat separated from adjacent open areas. It is overlooked by a properties on one side. Not visible from footpaths or traffic.	There are no formal footpaths, which would make accessibility by wheeled users difficult.	Site is close to a school, shops, scout hut, toilets.	Site has 100% residential coverage.	Physical: Fast traffic on Cannock Road, though there is a pedestrian crossing. Lack of footpath adjacent to path on Elder Lane. Social: None	Opportunities to run/walk, Ability to play ball games, Opportunities to sit/hang out, Risky play, Well maintained	Equipment is good for young children. All in good working order.		
Suggested Improvements

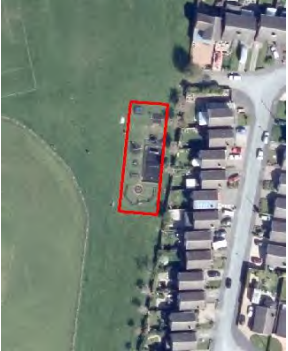
<ul style="list-style-type: none"> Visible from properties fronting onto site, Visible by traffic – moderate residential volume and speed Visible from footpaths <p>100% overlooked -0% not overlooked</p>	<ul style="list-style-type: none"> Open during daylight Level even surfaces for pushchairs & wheelchairs Seating opportunities both formal and informal <p>100% inclusive – 0% not inclusive</p>	<p>Opportunities to travel to play on route to other events</p> <ul style="list-style-type: none"> Shops, community buildings, school <p>100% multi facilities – 0% no facilities</p>	<p>Within 480m /10 min walk time</p> <p>100% full residential coverage – 0% no coverage</p>	<p>Physical</p> <ul style="list-style-type: none"> Railway lines, busy roads, canals, poor footpath links etc. <p>Social</p> <ul style="list-style-type: none"> Local youth disputes, negative attitudes of residents to children <p>100% no barriers – 0% barriers</p>	<ul style="list-style-type: none"> Opportunities to run/walk Hard surface to cycle, basketball, roller skate, skateboard Ability to play ball games Opportunities to sit/hang out Risky play – climbing, jumping, swinging Natural play – hills, tress Well maintained – bins, litter <p>100% 5 out of 7 – 0% 0 out of 7</p>	<p>Broken equipment or in need of repair</p> <p>100% excellent condition – 0% poor condition</p>	<p>Site is well maintained and provides a range of play facilities.</p> <p>Site only provides for part of the village due to its location on the edge of the settlement. Opportunities for another play area in the eastern half of the village should be explored.</p> <p>Potential to introduce natural play and areas of hard surfacing to the site.</p>

Score								
60%	100%	20%	50%	100% Physical, 100% Social	100%	90%		
Comments								
<p>Overlooked by cricket club and football field. Overlooked by rear upper windows of adjacent properties. No footpaths, but site used well by dog walkers.</p>	<p>Surfaces are level although there are no footpaths within this site. Plenty of seating.</p>	<p>Near cricket club.</p>	<p>Due to the sites location on the edge of the settlement the catchment only covers part of the village.</p>	<p>Physical: None</p> <p>Social: None</p>	<p>Opportunities to run/walk, Ability to play ball games, Opportunities to sit/hang out, Risky play, Well maintained</p>	<p>Equipment appears well used, though looks shabby.</p>		
Suggested Improvements								
None	<p>Potential to introduce footpaths to the site, though this may detract from the open natural feel.</p>	None	<p>Little potential to improve this score.</p>	None	<p>Potential to introduce natural play, and hard surfaces.</p>	<p>Equipment would benefit from repainting.</p>

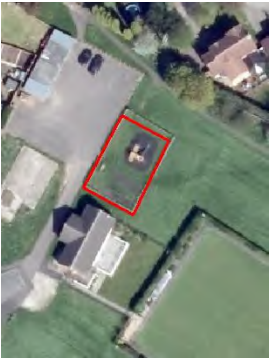
<ul style="list-style-type: none"> Visible from properties fronting onto site, Visible by traffic – moderate residential volume and speed Visible from footpaths 100% overlooked -0% not overlooked	<ul style="list-style-type: none"> Open during daylight Level even surfaces for pushchairs & wheelchairs Seating opportunities both formal and informal 100% inclusive – 0% not inclusive	Opportunities to travel to play on route to other events <ul style="list-style-type: none"> Shops, community buildings, school 100% multi facilities – 0% no facilities	Within 480m /10 min walk time 100% full residential coverage – 0% no coverage	Physical <ul style="list-style-type: none"> Railway lines, busy roads, canals, poor footpath links etc. Social <ul style="list-style-type: none"> Local youth disputes, negative attitudes of residents to children 100% no barriers – 0% barriers	<ul style="list-style-type: none"> Opportunities to run/walk Hard surface to cycle, basketball, roller stake, skateboard Ability to play ball games Opportunities to sit/hang out Risky play – climbing, jumping, swinging Natural play – hills, tress Well maintained – bins, litter 100% 5 out of 7 – 0% 0 out of 7	Broken equipment or in need of repair 100% excellent condition – 0% poor condition	Equipment is all in good condition offering good play value. Site is on a slope with no footpaths or hard surfaces around equipment. This could make access for wheeled users difficult. Potential to improve this with footpaths and hard surfaces. Due to the location within a large green space there is potential to increase the size of this play area.

Score								
20%	50%	70%	100%	100% Physical, 100% Social	100%	100%		
Comments								
Limited visibility from rear of properties to one side. Adjacent to garage court and parking area. Adjacent to hall.	Site is not flat, no hard surfaces around equipment. Plenty of informal seating but no formal seating.	Local shops are a short walk away, other services located to the north of the site.	Site is located within a residential area to the west of the settlement.	Physical: None Social: None	Opportunities to run/walk, Ability to play ball games, Opportunities to sit/hang out, Risky play, Natural play, Well maintained. Limited natural play elements.	Equipment is in good condition. Grass under equipment is becoming worn. One fence panel broken at time of visit.		
Suggested Improvements								
No potential to increase this score.	Explore opportunities for formal seating and improved surfacing.	None	None	None	Potential to improve natural play and add hard surface. Site is located within a large green space, potential to increase the size of play area.	Potential to improve surface under equipment to reduce grass wearing. Repair or replace fencing.

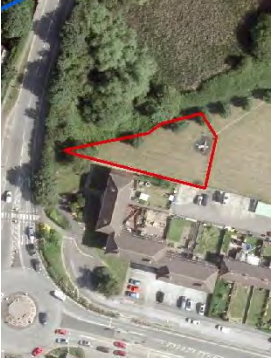
Play Location Victory Terrace, Fazeley Young children's climbing frame

Degree to which play area is overlooked, perception of safety <ul style="list-style-type: none"> Visible from properties fronting onto site, Visible by traffic – moderate residential volume and speed Visible from footpaths 100% overlooked -0% not overlooked	Degree to which site is 'inclusive' <ul style="list-style-type: none"> Open during daylight Level even surfaces for pushchairs & wheelchairs Seating opportunities both formal and informal 100% inclusive – 0% not inclusive	Proximity to other services & facilities Opportunities to travel to play on route to other events <ul style="list-style-type: none"> Shops, community buildings, school 100% multi facilities – 0% no facilities	Does it have highest catchment coverage Within 480m /10 min walk time 100% full residential coverage – 0% no coverage	Accessibility barriers Physical <ul style="list-style-type: none"> Railway lines, busy roads, canals, poor footpath links etc. Social <ul style="list-style-type: none"> Local youth disputes, negative attitudes of residents to children 100% no barriers – 0% barriers	Play value – Children's criteria (must have at least 5 out of 7) <ul style="list-style-type: none"> Opportunities to run/walk Hard surface to cycle, basketball, roller stake, skateboard Ability to play ball games Opportunities to sit/hang out Risky play – climbing, jumping, swinging Natural play – hills, tress Well maintained – bins, litter 100% 5 out of 7 – 0% 0 out of 7	Equipment quality Broken equipment or in need of repair 100% excellent condition – 0% poor condition	Overall comments Very poor site which is in need of replacing. The equipment is limited and does not offer many play opportunities. The site is underused and is located poorly, as it is hidden behind the adjacent flats and separated from the wider residential area. The play area is also fenced off within the wider green space in which it is located. There is need to improve this site with new equipment and landscaping. However due to its location it may be worthwhile to relocate the play area to a preferable site within the residential area.

Score								
50%	0%	80%	50%	50% Physical, 100% Social	40%	20%		
Comments								
Site is overlooked by the adjacent properties.	There is no seating or level surfaces within this site.	Site is in close proximity to the local shops and community facilities in Fazeley.	Catchment covers residential area with the District and parts of Tamworth Borough. The catchment contains some industrial uses.	Physical: Busy roads separate the site from much of its catchment and the whole site is surrounded by obtrusive fencing. Social: None	Opportunities to run/walk, Risky play. Very poor site which offers little in play value. Site consists of one small climbing frame for young children.	Equipment is in poor condition and rusted.		
Suggested Improvements								
None	Opportunities to introduce seating and level surfaces.	None	Little opportunity to improve this score.	Improve access into the site and remove fencing which currently limits access.	Site requires significant improvement. The site is underutilised and has great potential to be remodelled.	Equipment needs replacing and whole site needs remodelling.

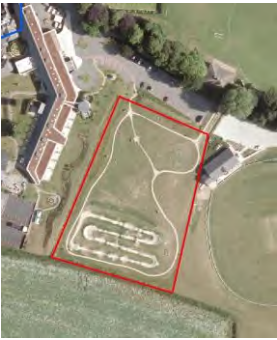
<ul style="list-style-type: none"> Visible from properties fronting onto site, Visible by traffic – moderate residential volume and speed Visible from footpaths 100% overlooked -0% not overlooked	<ul style="list-style-type: none"> Open during daylight Level even surfaces for pushchairs & wheelchairs Seating opportunities both formal and informal 100% inclusive – 0% not inclusive	Opportunities to travel to play on route to other events <ul style="list-style-type: none"> Shops, community buildings, school 100% multi facilities – 0% no facilities	Within 480m /10 min walk time 100% full residential coverage – 0% no coverage	Physical <ul style="list-style-type: none"> Railway lines, busy roads, canals, poor footpath links etc. Social <ul style="list-style-type: none"> Local youth disputes, negative attitudes of residents to children 100% no barriers – 0% barriers	<ul style="list-style-type: none"> Opportunities to run/walk Hard surface to cycle, basketball, roller stake, skateboard Ability to play ball games Opportunities to sit/hang out Risky play – climbing, jumping, swinging Natural play – hills, tress Well maintained – bins, litter 100% 5 out of 7 – 0% 0 out of 7	Broken equipment or in need of repair 100% excellent condition – 0% poor condition	An excellent site, which offers a unique facility within the village, and the District. Beautifully maintained.

Score								
20%	80%	20%	30%	100% Physical, 100% Social	100%	100%		
Comments								
Visibility is limited due to location. Site is visible from the adjacent cricket ground and hospice.	There is a good footpath through the site, though the site is located on a hill so may be difficult for some wheeled users. Numerous benches in the site, located adjacent to the path.	Site is located near the cricket ground.	Due to location on edge of settlement a majority of the catchment is outside of the village.	Physical: None Social: None	Opportunities to run/walk, Ability to play ball games, Opportunities to sit/hang out, Risky play, Natural play, Well maintained. Risky play is included due to the BMX track.	Equipment is in good condition. BMX track looks used regularly, but is well maintained.		
Suggested Improvements								
No potential to improve this score.	None	Limited potential to improve this score.	No potential to improve this.	None	Due to the nature of this site introducing hard surfaces wouldn't be appropriate.	None

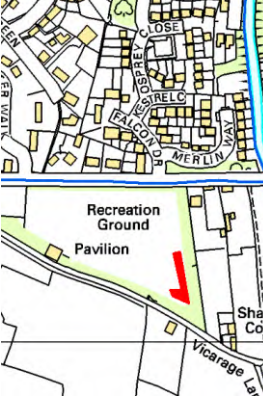
<ul style="list-style-type: none"> Visible from properties fronting onto site, Visible by traffic – moderate residential volume and speed Visible from footpaths <p>100% overlooked -0% not overlooked</p>	<ul style="list-style-type: none"> Open during daylight Level even surfaces for pushchairs & wheelchairs Seating opportunities both formal and informal <p>100% inclusive – 0% not inclusive</p>	<p>Opportunities to travel to play on route to other events</p> <ul style="list-style-type: none"> Shops, community buildings, school <p>100% multi facilities – 0% no facilities</p>	<p>Within 480m /10 min walk time</p> <p>100% full residential coverage – 0% no coverage</p>	<p>Physical</p> <ul style="list-style-type: none"> Railway lines, busy roads, canals, poor footpath links etc. <p>Social</p> <ul style="list-style-type: none"> Local youth disputes, negative attitudes of residents to children <p>100% no barriers – 0% barriers</p>	<ul style="list-style-type: none"> Opportunities to run/walk Hard surface to cycle, basketball, roller stake, skateboard Ability to play ball games Opportunities to sit/hang out Risky play – climbing, jumping, swinging Natural play – hills, tress Well maintained – bins, litter <p>100% 5 out of 7 – 0% 0 out of 7</p>	<p>Broken equipment or in need of repair</p> <p>100% excellent condition – 0% poor condition</p>	<p>Poor site, underwhelming for the size of the green space in which it is located. Equipment is limited and in poor condition, also feels randomly placed within the site.</p> <p>Potential to improve this site and the wider green space. Explore opportunities for new equipment or even relocating play area to another part of the green space.</p>

Score								
20%	50%	30%	30%	100% Physical, 100% Social	100%	50%		
Comments

<p>Overlooked by other users of recreational ground, not visible from properties or traffic. Used well by dog walkers at time of visit.</p>	<p>Grass surfaces are even, though no footpaths to equipment. Limited seating near some of the play equipment. No lighting.</p>	<p>Site is located near the cricket ground.</p>	<p>Due to location on edge of settlement a majority of the catchment is outside of the village.</p>	<p>Physical: None</p> <p>Social: None</p>	<p>Opportunities to run/walk, Ability to play ball games, Opportunities to sit/hang out, Risky play, Well maintained.</p>	<p>Equipment is old and in need of replacement, all in working order though. Surfacing in fenced play area is in poor condition.</p>		
Suggested Improvements								
None	Introduce footpaths across site. Locate some seating near fenced play area.	Limited potential to improve this score.	No potential to improve this.	None	Potential to improve play value with the addition of more equipment, hard surfaces and natural play.	Repair/replace equipment, opportunities to for additional play equipment. Repair/replace surfacing in fenced play area.

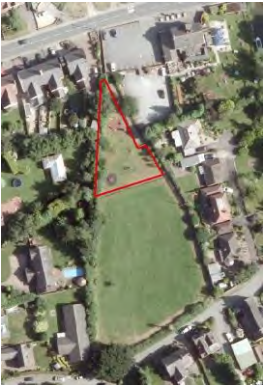
Play Location	Degree to which play area is overlooked, perception of safety	Degree to which site is 'inclusive'	Proximity to other services & facilities	Does it have highest catchment coverage	Accessibility barriers	Play value – Children's criteria (must have at least 5 out of 7)	Equipment quality	Overall comments
<p>Nursery Lane, Hopwas</p> <p>Play equipment for younger children</p>

<ul style="list-style-type: none"> Visible from properties fronting onto site, Visible by traffic – moderate residential volume and speed Visible from footpaths <p>100% overlooked -0% not overlooked</p>	<ul style="list-style-type: none"> Open during daylight Level even surfaces for pushchairs & wheelchairs Seating opportunities both formal and informal <p>100% inclusive – 0% not inclusive</p>	<p>Opportunities to travel to play on route to other events</p> <ul style="list-style-type: none"> Shops, community buildings, school <p>100% multi facilities – 0% no facilities</p>	<p>Within 480m /10 min walk time</p> <p>100% full residential coverage – 0% no coverage</p>	<p>Physical</p> <ul style="list-style-type: none"> Railway lines, busy roads, canals, poor footpath links etc. <p>Social</p> <ul style="list-style-type: none"> Local youth disputes, negative attitudes of residents to children <p>100% no barriers – 0% barriers</p>	<ul style="list-style-type: none"> Opportunities to run/walk Hard surface to cycle, basketball, roller skate, skateboard Ability to play ball games Opportunities to sit/hang out Risky play – climbing, jumping, swinging Natural play – hills, tress Well maintained – bins, litter <p>100% 5 out of 7 – 0% 0 out of 7</p>	<p>Broken equipment or in need of repair</p> <p>100% excellent condition – 0% poor condition</p>	<p>Well positioned site that offers important play facilities to the settlement.</p> <p>The majority of the equipment is in need for refurbishment. There is potential to increase the play opportunities within the wider green space, which could include introducing natural play.</p> <p>Site is well maintained although the surfacing of the play area needs some attention.</p>

Score								
40%	70%	50%	100%	100%	50% Physical, 100% Social	100%	70%	
Comments								
<p>Site is not overlooked well. Some properties are in view of the site along with the adjacent scout hut, also visible from the adjacent footpath. The current hedge heights shield the sight from view, particularly from the road.</p>	<p>The path along the edge of the site is flat and even. The play area is not even and is grassed, this may make it difficult for wheeled users. Limited seating on offer in the play area and wider green space.</p>	<p>Site is located close to several pubs and adjacent to the scout hut.</p>	<p>The majority of the settlement is within the catchment. The site has two entrances which makes it easier to access.</p>	<p>Physical: The canal and busy road separate the site from parts of the village. However there are two canal bridges and a formal pedestrian crossing which makes access easier.</p> <p>Social: None</p>	<p>Opportunities to run/walk, Ability to play ball games, Opportunities to sit/hangout, Risky play, Well maintained.</p>	<p>The majority of the equipment is old and in need of refurbishment. All equipment is in working order.</p>

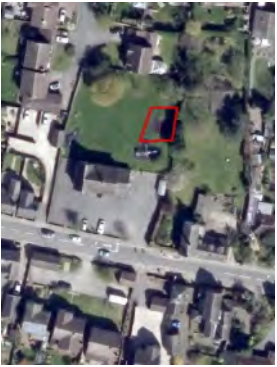
<p>Play Location</p> <p>Alrewas Road, Kings Bromley</p> <p>Small play area with swings, slide and climbing frame</p>

<p>Degree to which play area is overlooked, perception of safety</p> <ul style="list-style-type: none"> Visible from properties fronting onto site, Visible by traffic – moderate residential volume and speed Visible from footpaths <p>100% overlooked -0% not overlooked</p>	<p>Degree to which site is 'inclusive'</p> <ul style="list-style-type: none"> Open during daylight Level even surfaces for pushchairs & wheelchairs Seating opportunities both formal and informal <p>100% inclusive – 0% not inclusive</p>	<p>Proximity to other services & facilities</p> <p>Opportunities to travel to play on route to other events</p> <ul style="list-style-type: none"> Shops, community buildings, school <p>100% multi facilities – 0% no facilities</p>	<p>Does it have highest catchment coverage</p> <p>Within 480m /10 min walk time</p> <p>100% full residential coverage – 0% no coverage</p>	<p>Accessibility barriers</p> <p>Physical</p> <ul style="list-style-type: none"> Railway lines, busy roads, canals, poor footpath links etc. <p>Social</p> <ul style="list-style-type: none"> Local youth disputes, negative attitudes of residents to children <p>100% no barriers – 0% barriers</p>	<p>Play value – Children's criteria (must have at least 5 out of 7)</p> <ul style="list-style-type: none"> Opportunities to run/walk Hard surface to cycle, basketball, roller stake, skateboard Ability to play ball games Opportunities to sit/hang out Risky play – climbing, jumping, swinging Natural play – hills, tress Well maintained – bins, litter <p>100% 5 out of 7 – 0% 0 out of 7</p>	<p>Equipment quality</p> <p>Broken equipment or in need of repair</p> <p>100% excellent condition – 0% poor condition</p>	<p>Overall comments</p> <p>A good site with equipment in good condition. This site offers the only play facility in the village.</p> <p>Small site with limited potential to further improve this site with additional play equipment, natural play or hard surfaces for ball games etc.</p>

Score								
75%	100%	100%	40%	80% Physical, 100% Social	100%	100%		
Comments								
Site is overlooked by houses on two sides also overlooked by the village hall.	Site is flat with seating. The only informal seating would be the grassed area.	Site is close the primary school, and adjacent to the village hall.	Catchment covers the majority of the village.	Physical: Alrewas Road is busy with high speeds. The pedestrian crossing is a short walk away from the play area. Social: None	Opportunities to run/walk, Ability to play ball games, Opportunities to sit/hang out, Risky play, Well maintained	All in good condition, swings and slide look like they've been recently painted and the climbing frame looks new.		
Suggested Improvements								
None	Potential to introduce more informal seating.	None	None		Opportunity to introduce either natural play or hard surfacing.	None		
Max score								
75%	100%	100%	100%	100% / 100%	100%	100%

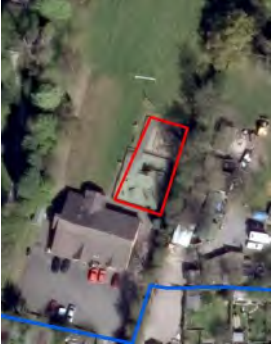
<p>Play Location</p> <p>Bellamour Way, Colton</p> <p>This site hosts play equipment for young children, swings and football posts.</p>

<p>Degree to which play area is overlooked, perception of safety</p> <ul style="list-style-type: none"> Visible from properties fronting onto site, Visible by traffic – moderate residential volume and speed Visible from footpaths <p>100% overlooked -0% not overlooked</p>	<p>Degree to which site is 'inclusive'</p> <ul style="list-style-type: none"> Open during daylight Level even surfaces for pushchairs & wheelchairs Seating opportunities both formal and informal <p>100% inclusive – 0% not inclusive</p>	<p>Proximity to other services & facilities</p> <p>Opportunities to travel to play on route to other events</p> <ul style="list-style-type: none"> Shops, community buildings, school <p>100% multi facilities – 0% no facilities</p>	<p>Does it have highest catchment coverage</p> <p>Within 480m /10 min walk time</p> <p>100% full residential coverage – 0% no coverage</p>	<p>Accessibility barriers</p> <p>Physical</p> <ul style="list-style-type: none"> Railway lines, busy roads, canals, poor footpath links etc. <p>Social</p> <ul style="list-style-type: none"> Local youth disputes, negative attitudes of residents to children <p>100% no barriers – 0% barriers</p>	<p>Play value – Children's criteria (must have at least 5 out of 7)</p> <ul style="list-style-type: none"> Opportunities to run/walk Hard surface to cycle, basketball, roller stake, skateboard Ability to play ball games Opportunities to sit/hang out Risky play – climbing, jumping, swinging Natural play – hills, tress Well maintained – bins, litter <p>100% 5 out of 7 – 0% 0 out of 7</p>	<p>Equipment quality</p> <p>Broken equipment or in need of repair</p> <p>100% excellent condition – 0% poor condition</p>	<p>Overall comments</p> <p>Good site which offers a range of play opportunities within a well maintained wider green space. Caters mainly for younger children.</p> <p>Potential to increase play value through natural play. Could add hard surfacing (eg: MUGA) or other equipment to cater for older children/teenagers.</p>

<p>Score</p>								
20%	100%	100%	50%	100% Physical, 100% Social	100%	90%		
<p>Comments</p>								
Only overlooked by village hall. Not visible from footpaths or traffic.	Level surfaces throughout, all hard surfacing around equipment. Lots of formal seating.	Site is adjacent to the village hall. School is short distance along the street.	Majority of the village is within the catchment, although much of the catchment is countryside due to location on edge on settlement.	Physical: None Social: None	Opportunities to run/walk, Ability to play ball games, Opportunities to sit/hang out, Risky play, Well maintained.	Most of equipment is in good condition.		
<p>Suggested Improvements</p>								
No potential to improve this score.	None	None	No potential to improve this score.	None	Potential to introduce natural play and hard surfaces within wider green space.	None		
<p>Max score</p>								
20%	100%	100%	100%	100%/100%	100%	100%

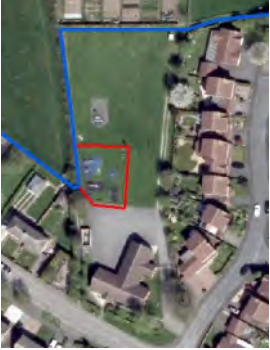
<p>Play Location</p> <p>Oaklands Close, Hill Ridware</p> <p>Play equipment for younger children, MUGA.</p>

<p>Degree to which play area is overlooked, perception of safety</p> <ul style="list-style-type: none"> Visible from properties fronting onto site, Visible by traffic – moderate residential volume and speed Visible from footpaths <p>100% overlooked -0% not overlooked</p>	<p>Degree to which site is 'inclusive'</p> <ul style="list-style-type: none"> Open during daylight Level even surfaces for pushchairs & wheelchairs Seating opportunities both formal and informal <p>100% inclusive – 0% not inclusive</p>	<p>Proximity to other services & facilities</p> <p>Opportunities to travel to play on route to other events</p> <ul style="list-style-type: none"> Shops, community buildings, school <p>100% multi facilities – 0% no facilities</p>	<p>Does it have highest catchment coverage</p> <p>Within 480m /10 min walk time</p> <p>100% full residential coverage – 0% no coverage</p>	<p>Accessibility barriers</p> <p>Physical</p> <ul style="list-style-type: none"> Railway lines, busy roads, canals, poor footpath links etc. <p>Social</p> <ul style="list-style-type: none"> Local youth disputes, negative attitudes of residents to children <p>100% no barriers – 0% barriers</p>	<p>Play value – Children's criteria (must have at least 5 out of 7)</p> <ul style="list-style-type: none"> Opportunities to run/walk Hard surface to cycle, basketball, roller stake, skateboard Ability to play ball games Opportunities to sit/hang out Risky play – climbing, jumping, swinging Natural play – hills, tress Well maintained – bins, litter <p>100% 5 out of 7 – 0% 0 out of 7</p>	<p>Equipment quality</p> <p>Broken equipment or in need of repair</p> <p>100% excellent condition – 0% poor condition</p>	<p>Overall comments</p> <p>New play equipment on site. Excellently maintained.</p> <p>Site offers good play opportunities to village.</p>

<p>Score</p>								
70%	100%	100%	90%	100% Physical, 100% Social	100%	100%		
<p>Comments</p>								
<p>Site is overlooked on one side by properties. Adjacent to the village hall.</p>	<p>Surfacing is even with seating</p>	<p>Located a short walk from shops, adjacent to village hall. School is a short distance away by foot.</p>	<p>Catchment covers a large majority of the village. Due to the linear form of the village pedestrian routes are along the main road.</p>	<p>Physical: None</p> <p>Social: None</p>	<p>Opportunities to run/walk, Hard surface, Ability to play ball games, Opportunities to sit/hang out, Risky play, Well maintained.</p>	<p>Excellent equipment</p>		
<p>Suggested Improvements</p>								
None		No potential to improve this score.	None	None				
<p>Max score</p>								
70%	100%	100%	90%	100%	100%	100%	<p>Total Score: 750 / 760</p>
